CASE STUDY

Inmet Mining - Troilus Mining Reserves without Reservation

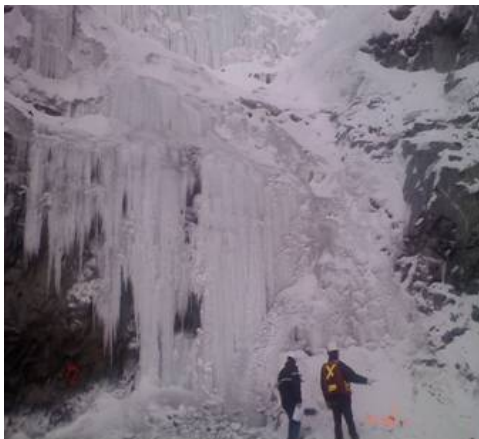
▲ Ice formations on mine pit walls

Because of the aggressive pit wall angle and prejudicial rock structural features associated with the freeze-thaw cycle experienced during spring, Troilus needed to continuously monitor the west wall in order to get rapid feedback of the conditions and take action as quickly as possible to assure employee safety and maximum ore recovery.

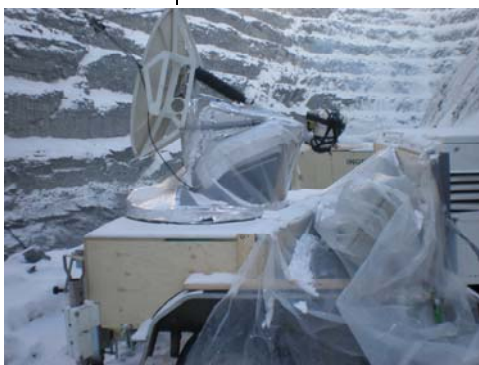
▲ Slope Stability Radar monitoring at Troilus pit

Several 9000 tonne failures were observed in February and March 2009, which the SSR depicted with total displacement of 50-70 mm before failure. The accuracy and precision of the radar allowed Troilus to safely access remaining ore while protecting employees and equipment.

GroundProbe and Troilus also overcame challenges related to operating the radar in extreme cold weather conditions. The average temperature from January to March was about -22°C, however, there were days in which the temperature was as low as -35°C with a wind chill factor of -45°C. A wooden box was built around most of the moving parts of the radar to provide insulation and protection from the elements. Other sensitive parts were covered with plastic tarp. Heat was pumped into the wooden box and under the tarps. The system has continued to function reliably despite the weather conditions.
