## SLOPE MONITORING STRATEGY AT PPRUST OPEN PIT OPERATION

M.J. Little

Rock Engineering Department, PPRust, Limpopo,  
South Africa

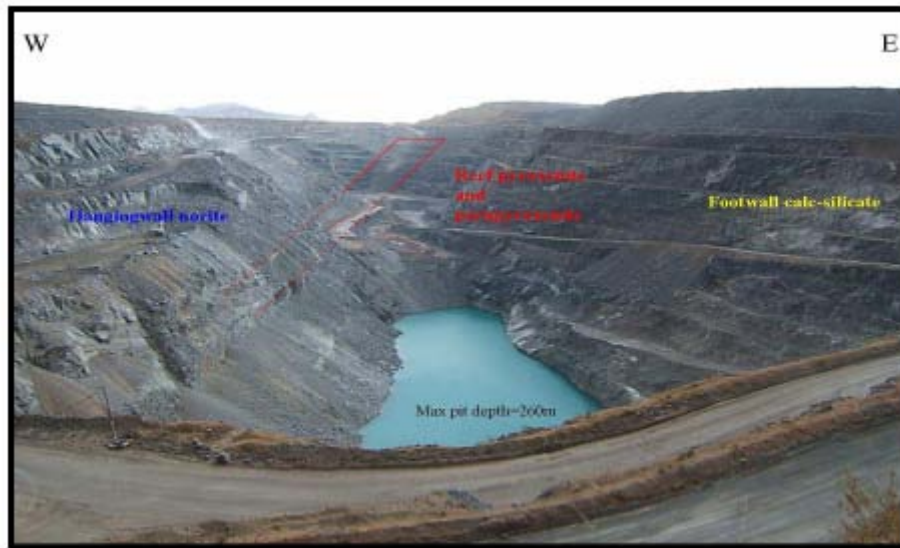
Figure 1 Platreef geology in Sandsloot open pit

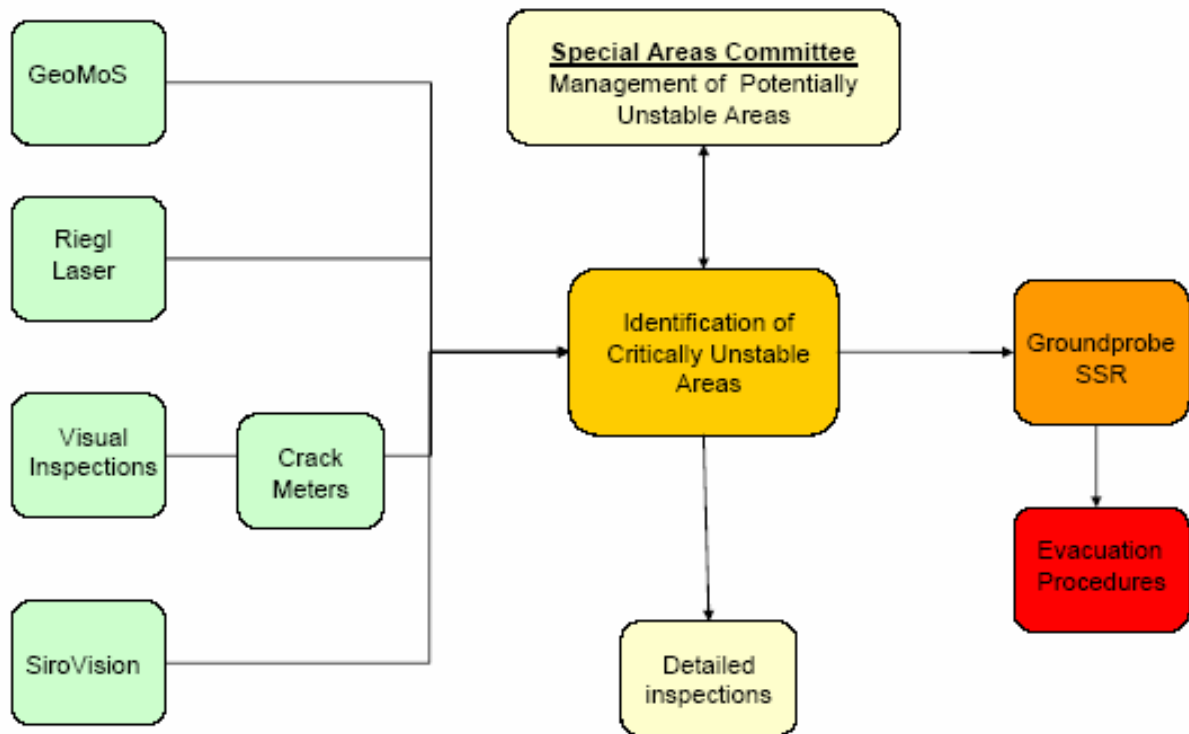
Figure 2 Slope monitoring strategy at PPRust

monitoring and visual monitoring have also been improved and crack meters are now installed wherever dangerous tension cracks are identified. To complement the visual inspections, SiroVision digital photogrammetry is used for predicting where future failures may occur. As shown in Figure 2, most of these monitoring tools provide primary monitoring which is used to identify high risk areas. The SSR is then set up in that area to provide early warning of failure so evacuation can be successfully done. Fault tree analysis has proved that with this comprehensive slope monitoring strategy the geotechnical risk at PPRust is greatly reduced, allowing mining to continue safely and economically in challenging conditions.

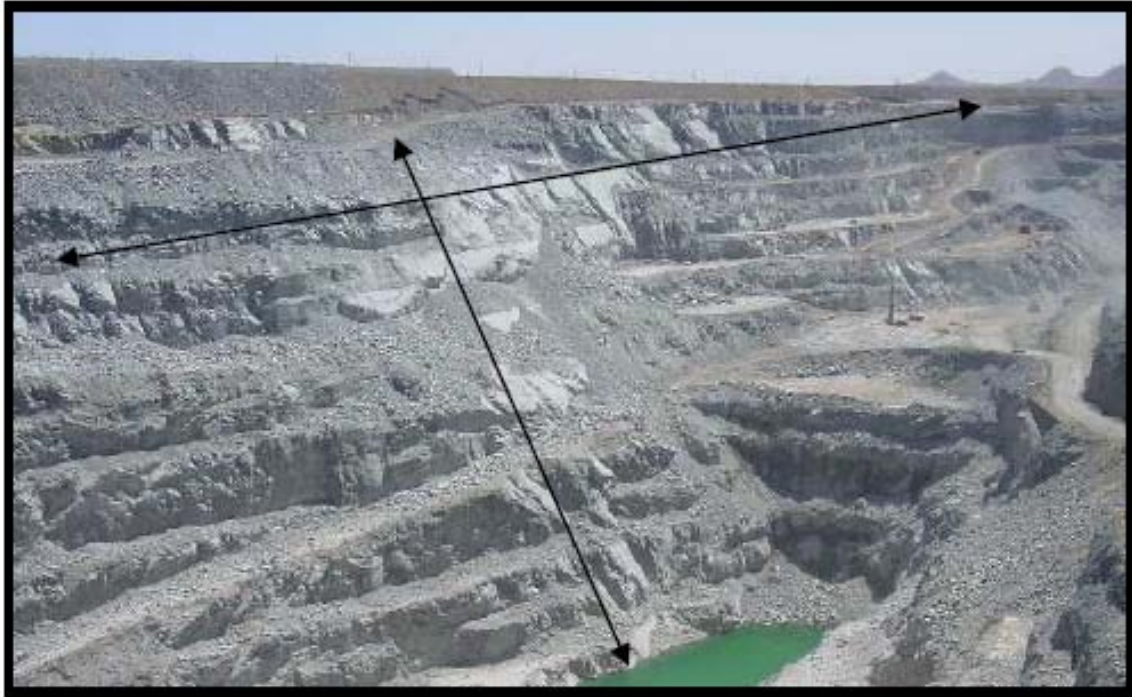
Figure 3 Photograph of fault zones cross-cutting the west wall of Sandsloot open pit.

The main slope stability concern at PPRust is stack failure on the western wall in Sandsloot open pit. These failures are a result of a large-scale fault zone that cross-cuts the entire west wall (Little, 2005). The 150 m wide fault zone hosts many faults spaced 5 m apart and joints spaced 20-50 cm apart which dip out of the face at roughly 55 degrees (Figure 3). Each one of these structures has the potential to cause failure. The failure mechanism is a combination of loss of cohesion on these planes and shearing through the rock bridge as a result of blasting. The failures are rapid brittle failures that occur in less than 2 hours and are of the order of tens to a few thousand tonnes.

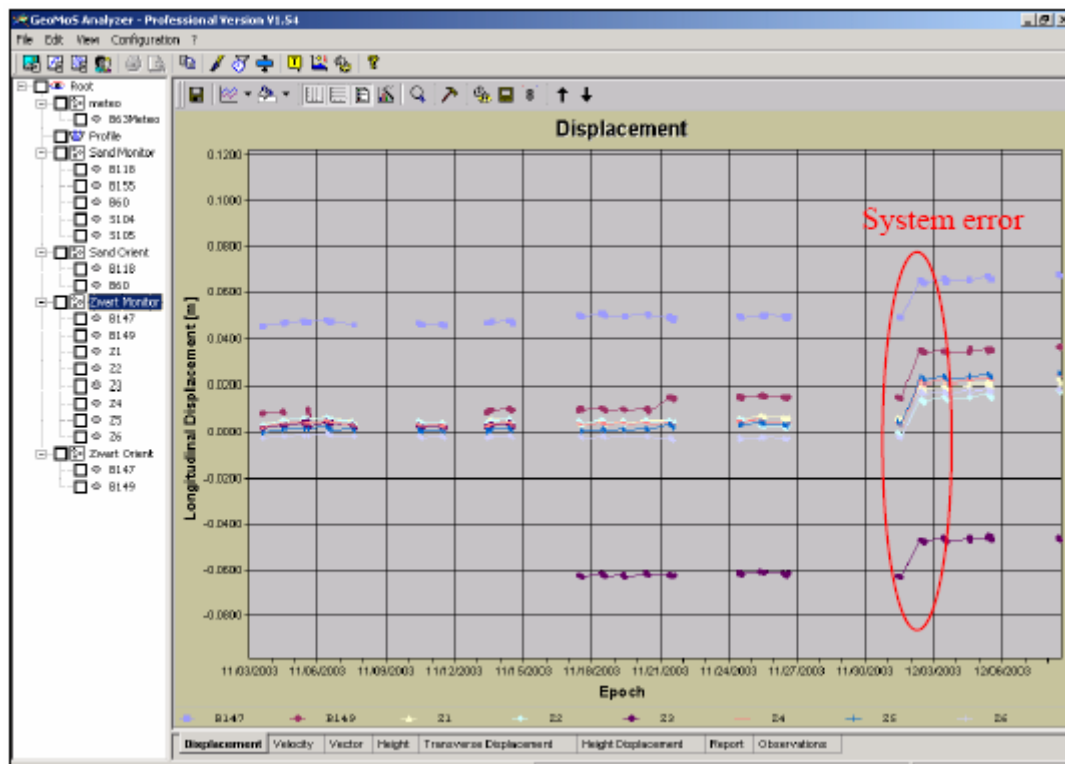
Figure 5 Longitudinal displacement plot in GeoMoS Analyser showing a system error

The GeoMoS system monitors the status of the total stations and allows the user to view the data graphically. The user can filter the data and plot graphs of displacement, velocity and vector movement of one or many selected prisms. There are 3 displacement plots – longitudinal (Figure 5), transverse and height - for the movement along the x, y and z axes. A vector plot combines these 3 movements into an absolute movement. A velocity plot uses the longitudinal displacement to calculate a displacement velocity. All the graphs can display raw or smoothed data and system errors can easily be identified as seen in Figure 5. The data from the prism monitoring is automatically stored in a customised MS Access database called SSMON. It is linked to the mine's draughting package, AutoCAD, which displays the movement vectors on cross-sections or 2D plans.

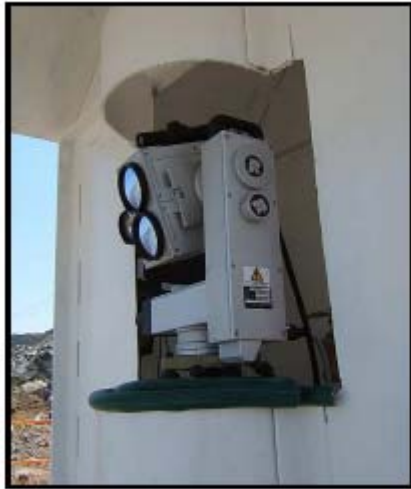
Figure 6 Laser installation

Prismless laser monitoring was introduced at PPRust in February 2005 to fill in the gaps where prisms have been lost or where they were never installed. Two Riegl LPM-2K laser scanners (Riegl, 2005) for slope monitoring are permanently installed in steel protective houses on the crest of the eastern highwalls in both Sandsloot and Zwartfontein South open pits (Figure 6). The laser scanners are battery operated, require no levelling and are eyesafe under all operating conditions. A camera is attached to the side of the laser and takes photographs at the start of scanning.

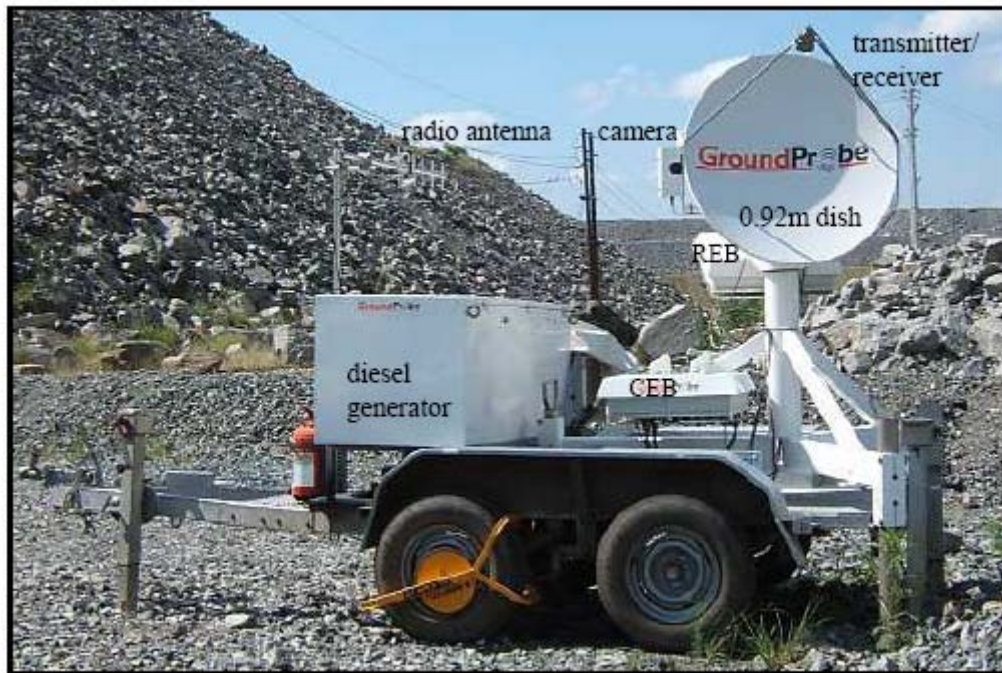
Figure 8 The GroundProbe Slope Stability Radar (SSR)

The SSR scanning antenna consists of a 0.92 m parabolic dish mounted on a sturdy tripod and controlled by motors and gears for horizontal and vertical movement. A diesel generator is housed at the back of the trailer and it powers the mechanical movements of the dish as well as the electronic equipment. The SSR is a mobile system that can be relocated in roughly an hour. A camera is fixed to the dish and photographs can be taken whenever required. Once set up and turned on, the SSR takes 14 photographs which it converts to a mosaic of the entire area that it can see and scan. The operator then selects a 2D scan area on the slope and scanning begins (Figure 9). The scan time is dependant on the size of the slope area selected and the distance from the slope. The range on the SSR is 850 m however that can be doubled if a 1.8 m dish is installed. An atmospheric region is selected on the scan region which is used to compensate for atmospheric disturbances caused by local changes in pressure, temperature and humidity.

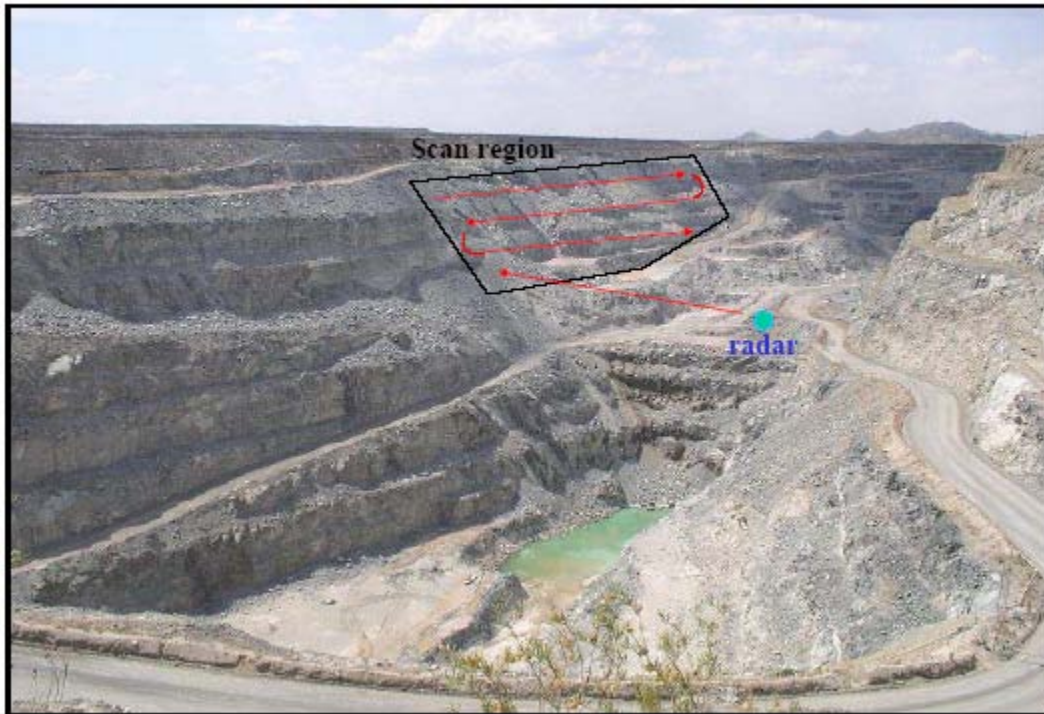
Figure 9 An example of the radar setup in Sandsloot open pit

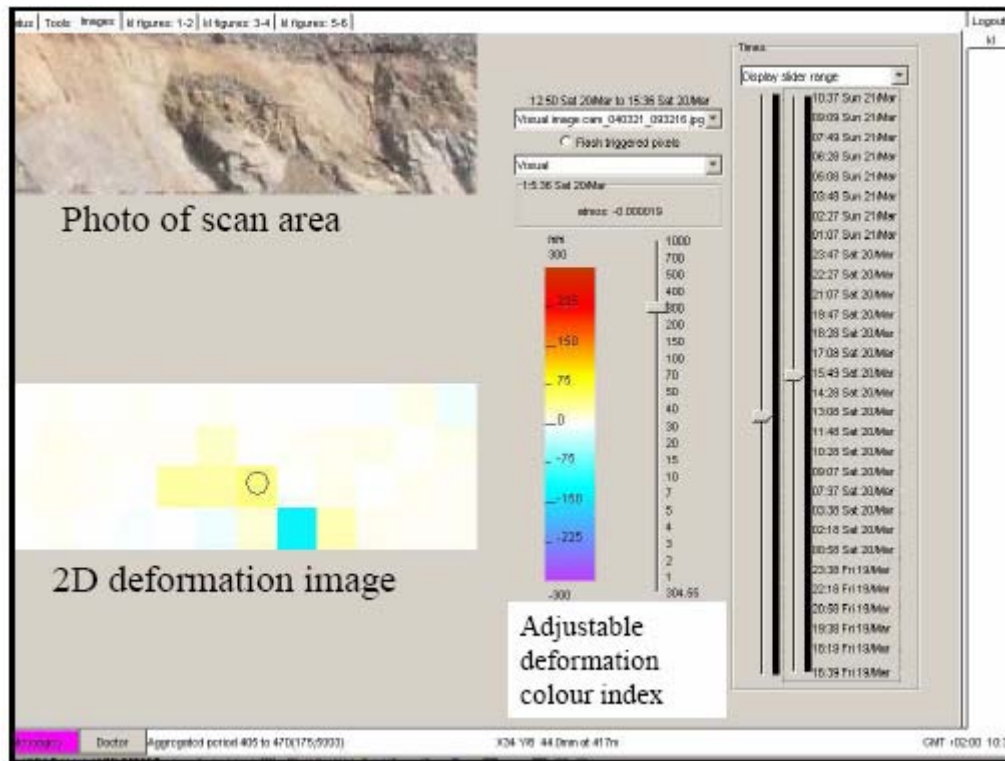
Figure 10 SSR viewing screen which shows a photograph of the scanned area, 2D deformation image, colour scale and time scale.

The SSR uses differential interferometry to measure sub-millimetre movements on a rough rock face (GroundProbe, 2005). It does this by comparing the phases of the radar signals it receives from one scan to the next. Any phase difference that it records is converted to a measurement in millimetres. It displays this information on a computer screen as a pixelated 2D image using hot and cold colours to indicate movement (Figure 10). The hot colours indicate movement out of the face and cold colours indicate movement away from the face – i.e. rocks have fallen out of the face. The most recent photograph of the scan area is shown next to the 2D image so that the operator can see where the movement is occurring on the slope. The operator can choose what time period (since the scanning started) to view as well as what level of movement to colour the plot on. At PPRust rapid brittle movements are monitored thus the maximum movement (red) is set at 15mm. Any number of deformation versus time graphs can be plotted on any area in the scan to make the interpretation of the data simpler. This will show the deformation history of a particular area. The operator can zoom in on the graphs as well as on the photographs and the deformation plots.

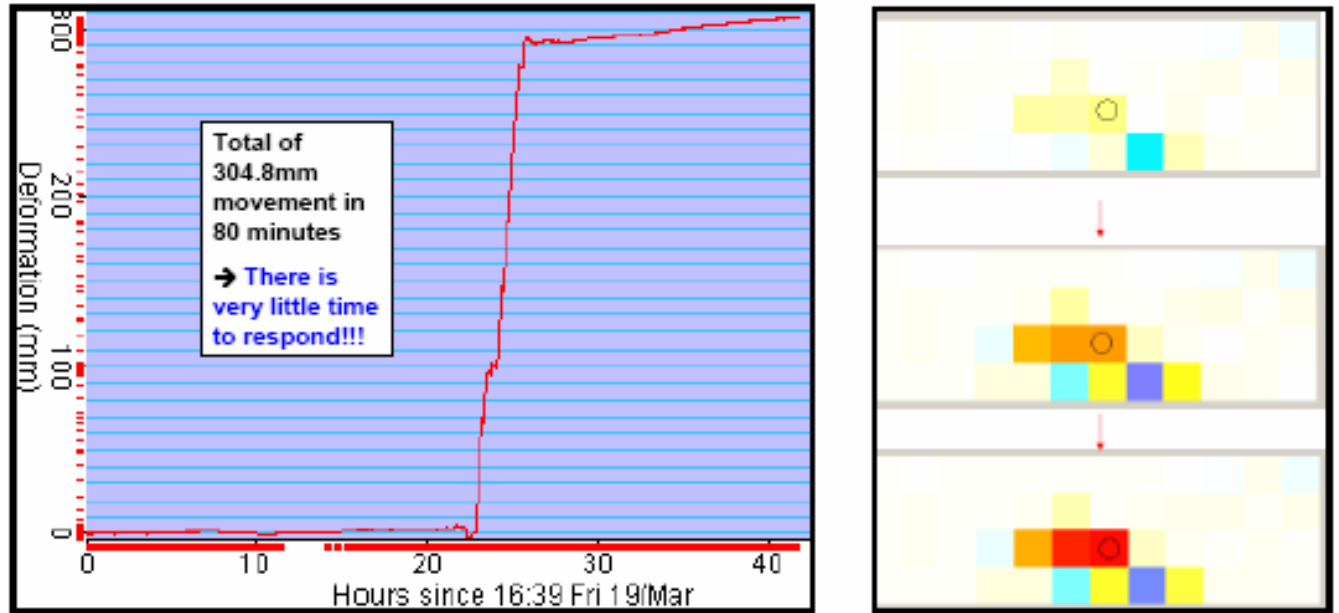
Figure 11 a) SSR deformation versus time plot of rapid brittle failure b) successive deformation images with change in colour showing the progressive movement

Eight brittle failures have been recorded in Sandsloot with the SSR and they all show that the slope movement occurs over less than 2 hours (Figure 11). This gives the operations staff very little time to respond – in some cases only 20 minutes. The SSR does provide early warning and people and equipment have been successfully evacuated at PPRust as a result. It is evident that at PPRust the SSR is the only monitoring tool that allows mining operations to continue safely under the high risk west wall in Sandsloot.
