## + CASE STUDY: Leinster Nickel Mine MAKING MINING SAFER

### SSR AT LEINSTER NICKEL OPERATIONS

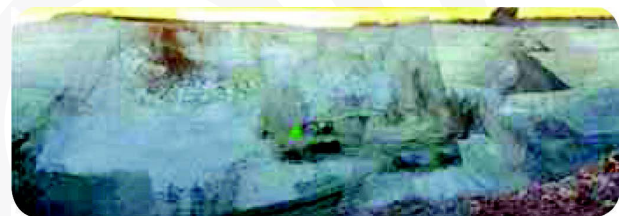
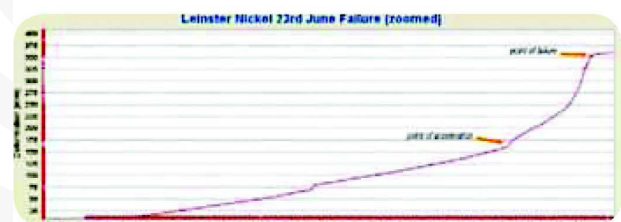
The data example above shows how the SSR provided LNO approximately 12 hours of warning prior to this failure.
