CASE STUDY:

Nchanga Open Pit

NCHANGA OPEN PIT (NOP) USES SSR TECHNOLOGY TO OPTIMISE SAFETY AND RECOVERY

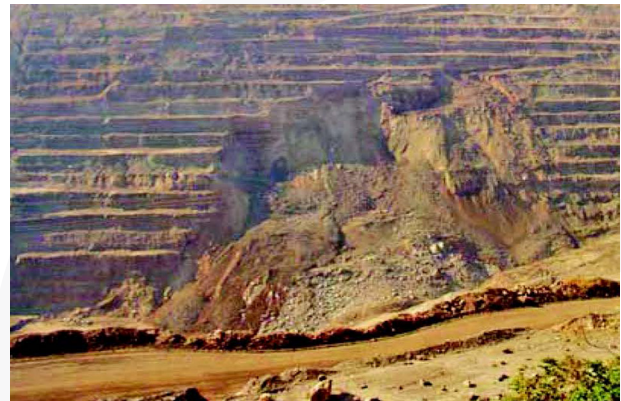
Nchanga Open Pit (NOP) uses SSR technology to optimise safety and recovery. In December 2003 a change in movement patterns occurred. Rates temporarily increased to 20mm/day or more in association with blasting and threshold rates increased to between 5 and 10mm/day. In April 2004, instantaneous rate associated with blasting exceeded 150mm/day and the threshold rate increased to 35mm/day.
